Quality Alert – Seat Sling for Select ExoFit™ Harnesses

Only Affects select ExoFit™ harnesses manufactured from June 2017 to the end of May 2018

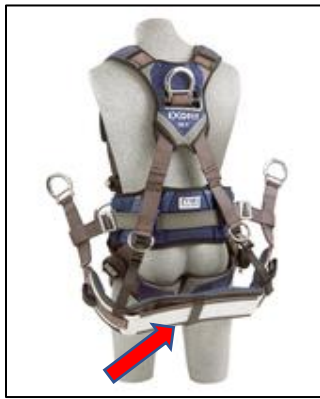
3M Fall Protection has received reports that the aluminum reinforcement plate used in the seat sling on certain DBI-SALA ExoFit™, ExoFit XP™ (inc. Arc Flash), and ExoFit NEX™ (inc. Arc Flash) harnesses can become dislodged from the webbing. In a few instances, the aluminum seat plate has separated from the harness and fallen to the ground, creating a potential dropped object hazard. There have been no reports of injuries or accidents associated with this condition. The performance of the harnesses is unaffected by this issue—they will perform properly in all respects, including as body support for a personal fall arrest system in the event of a fall, even without the added comfort offered by the seat sling.

Representative Seat Sling Indicated by Red Arrow

3M is offering a free warranty replacement of the seat sling for all DBI-SALA ExoFit™, ExoFit XP™ (inc. ArcFlash), and ExoFit NEX™ (inc. ArcFlash) harnesses with a seat sling, with a manufacture date of 17/06 (2017, June) through the end of 18/05 (2018, May) regardless of model number.

End-Users: Please inspect your harness, if you find a harness within the affected range with a seat sling, contact 3M Customer Service at 1-800-328-6146 or email us for your free replacement seat sling at 3musfbserviceaction@mmm.com. Please provide us with the model number and manufacture date when contacting us. After you receive your replacement seat sling, please remove your original sling from service and dispose of it.

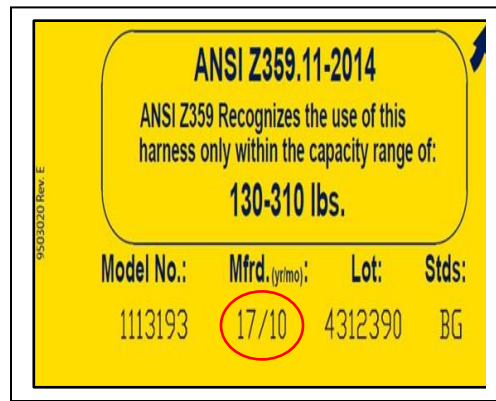
Manufacture Date on Harness shown in Red Circle

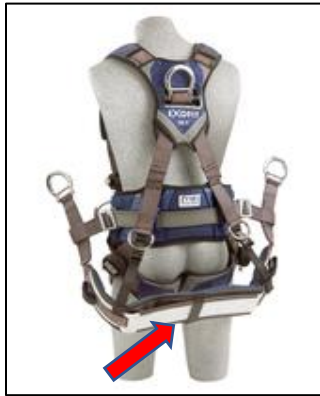
3M Fall Protection ha recibido informes que indican que la placa de refuerzo de aluminio que se usa en la eslinga de asiento puede desprenderse del tejido trenzado en ciertos arneses ExoFit™, ExoFit XP™ (incluyen los modelos para arco eléctrico) y ExoFit NEX™ (incluyen los modelos para arco eléctrico) DBI-SALA. En algunas circunstancias, la placa de asiento de aluminio se ha separado del arnés y se ha caído al suelo, lo que crea el peligro posible de una caída de un objeto. No hemos recibido ningún informe de lesiones o accidentes asociados con esta condición. El desempeño de los arneses no se ve afectado por este problema, por lo que cumplirán correctamente con su propósito en todo momento, hasta como sujeción del cuerpo para un sistema de detención de caídas personal en caso de que se produzca una caída, incluso sin la comodidad adicional que ofrece la eslinga de asiento.

La flecha roja señala la eslinga de asiento del ejemplo

3M ofrece, como parte de la garantía, un reemplazo sin cargo de la eslinga de asiento para todos los arneses ExoFit™, ExoFit XP™ (incluyen los modelos para arco eléctrico) y ExoFit NEX™ (incluyen los modelos para arco eléctrico) DBI-SALA, con una fecha de fabricación entre 17/06 (junio de 2017) y fines de 18/05 (mayo de 2018) independientemente del número de modelo.

Usuarios finales: Inspeccionen el arnés. Si ven que un arnés con eslinga de asiento se encuentra en el grupo de arneses afectados, comuníquense con el Servicio al cliente de 3M llamando al 1-800-328-6146 o envíenos un correo electrónico a 3musfbserviceaction@mmm.com para solicitar el reemplazo sin cargo alguno de la eslinga de asiento. Cuando se comuniquen con nosotros, proporcione el número de modelo y la fecha de fabricación. Una vez que reciba la eslinga de asiento de reemplazo, retire la eslinga original del servicio y descártela.

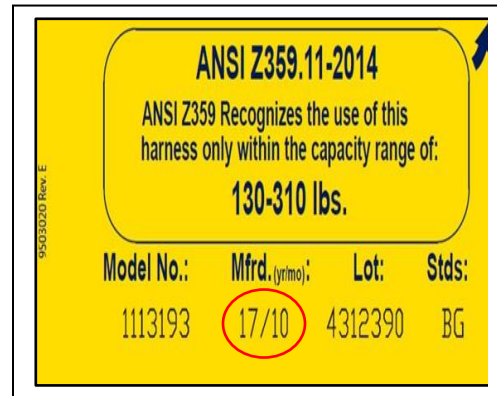
El círculo rojo muestra dónde se encuentra la fecha de fabricación en el arnés
