INSPECTION NOTICE - EDGE SERIES CABLE SELF-RETRACTING LIFELINES (SRL)

Guardian Fall Protection has discovered a small number of isolated housing screws backing out of Edge SRLs. The units affected by this notice are limited to 20' or 30' Edge Series Cable SRLs with a "G" engraving on the top of the unit housing. We have tested a representative sample of units with the housing screws removed, and all units exceeded all OSHA and ANSI requirements.

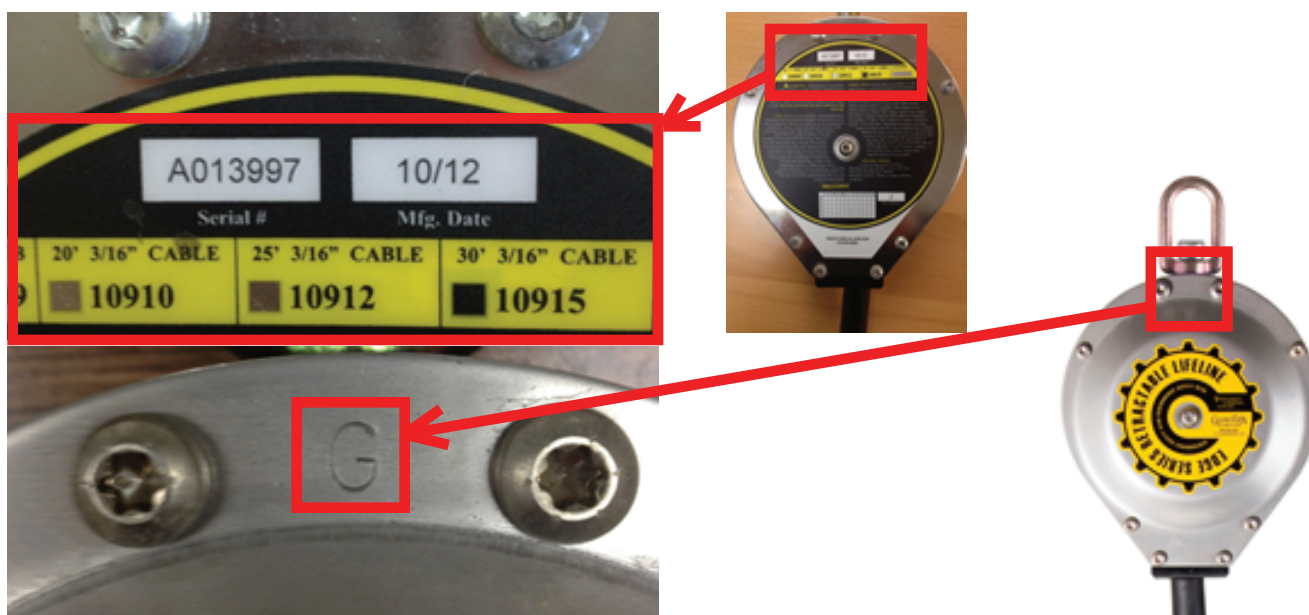
Find the part number on the back label in order to confirm if the unit is affected. Inspect the serial number in order to determine if it starts with the letter "A." Inspect the top of the unit housing for the "G" engraving. The unit requires inspection only if it is a #10910, #10915, #10920, #10922 or #10925, AND it has a "G" engraving. All other units are not affected.

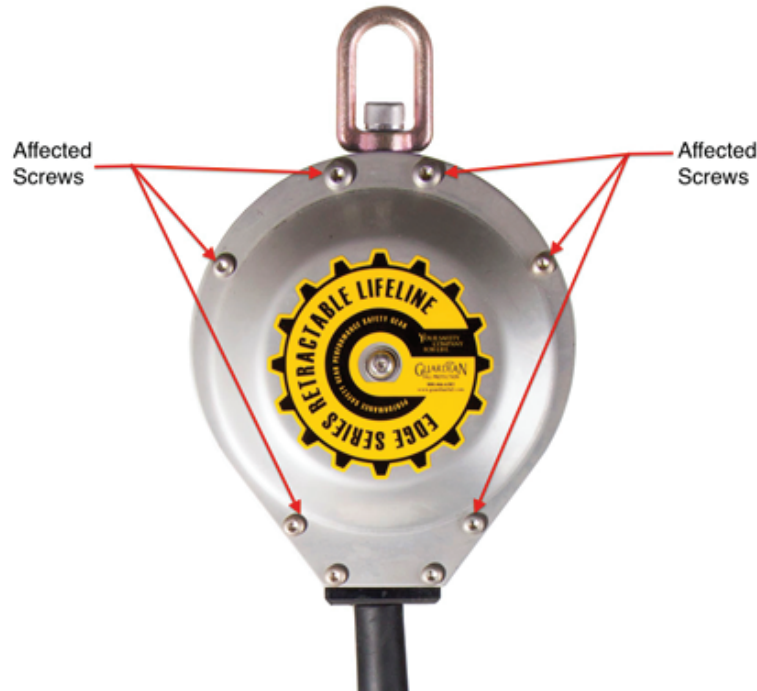
Inspect your inventory of 10910, 10915, 10920, 10922, and 10925 units using the instructions above. If the units have a serial number starting with the letter "A" and a "G" engraved between the top plate screws, inspect the screws immediately for the backed out screw condition. This inspection notice affects only the six (6) screws identified on the image below.

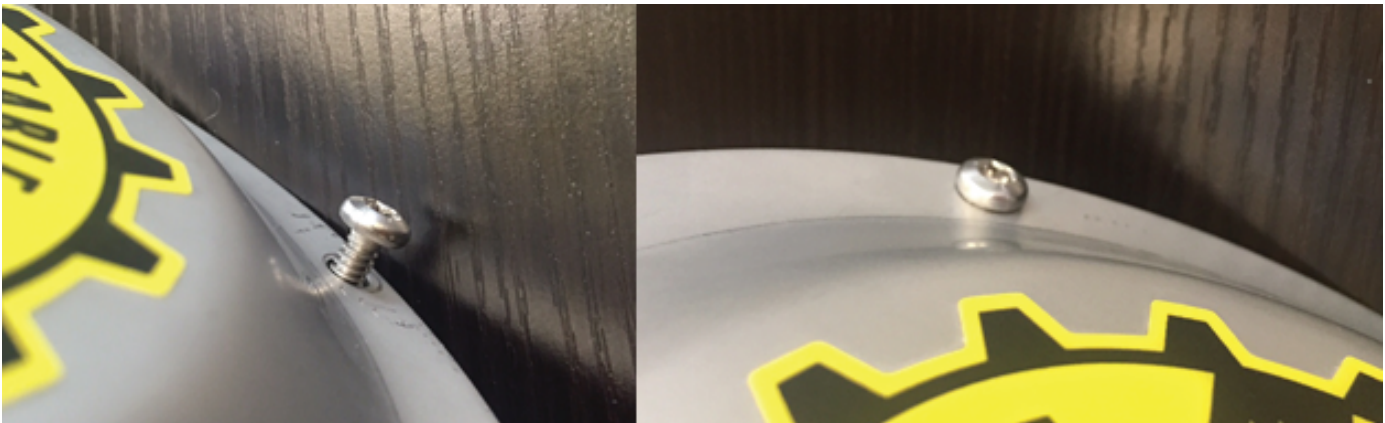
If all screw heads are not properly seated to the metal housing then remove the unit from service immediately and return it to Guardian Fall Protection for repair. The image on the left below shows a backed out screw, and the image on the right shows a properly seated screw. If there is a visible gap, to the unaided eye, between the bottom of the screw head and the metal housing, then the screw is backing out.

All affected units will have the defect repaired AND will be re-certified by Guardian free of charge including any necessary unit repairs. Guardian Customer Service will provide instructions for shipping returned product on Guardian's shipping account. Please direct any questions you may have to Customer Service at **CS@guardianfall.com** or **1-800-466-6835**.
