RECALL NOTICE

EB2200i • EU2200i Portable Generators FUEL LEAK FROM FUEL VALVE

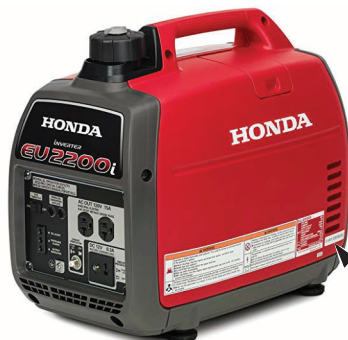
SERIAL
NUMBER

Affected Model	Starting Serial Number	Ending Serial Number
EB2200i	EAJT-1000001	EAJT-1005474
EU2200i EU2200i Companion EU2200i Camo	EAMT-1000001	EAMT-1260796

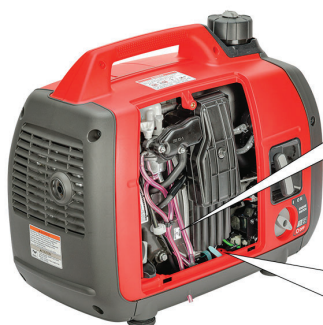
A "green dot" located on the carton.

A "7EP" label on the engine cover
OR
A black dot on the side cover boss.
